NEWPORT NEWS SHIPBUILDING CO VA F/G 13/10  
FURTHER SURVEY OF IN-SERVICE PERFORMANCE OF STRUCTURAL DETAILS.(U)  
MAY 80 C R JORDAN, L T KNIGHT DOT-CG-75172-A

SSC-294

**APRIL 1980  
SR-1258**

16. Abstract This project is an adjunct to the Ship Structure Committee report SSC-272. Using the same survey techniques and data analysis procedures described in that report, the midship/cargo areas of an additional twelve bulk carriers, twelve containerships, and twelve general cargo ships were surveyed under Project SR-1258. The goal of both projects is to provide design and repair personnel with structural service data and recommendations that can be used to significantly decrease the number of detail failures that occur on ships of all types. The data from both surveys are combined and summarized for ready use by design and repair offices.  Structural detail failure data were collected for twelve detail families (beam brackets, tripping brackets, non-tight collars, tight collars, gunwale connections, knife edge crossings, miscellaneous cutouts, clearance cuts, deck cutouts, stanchion ends, stiffener ends, and panel stiffeners) to provide guidance in the selection of structural detail co

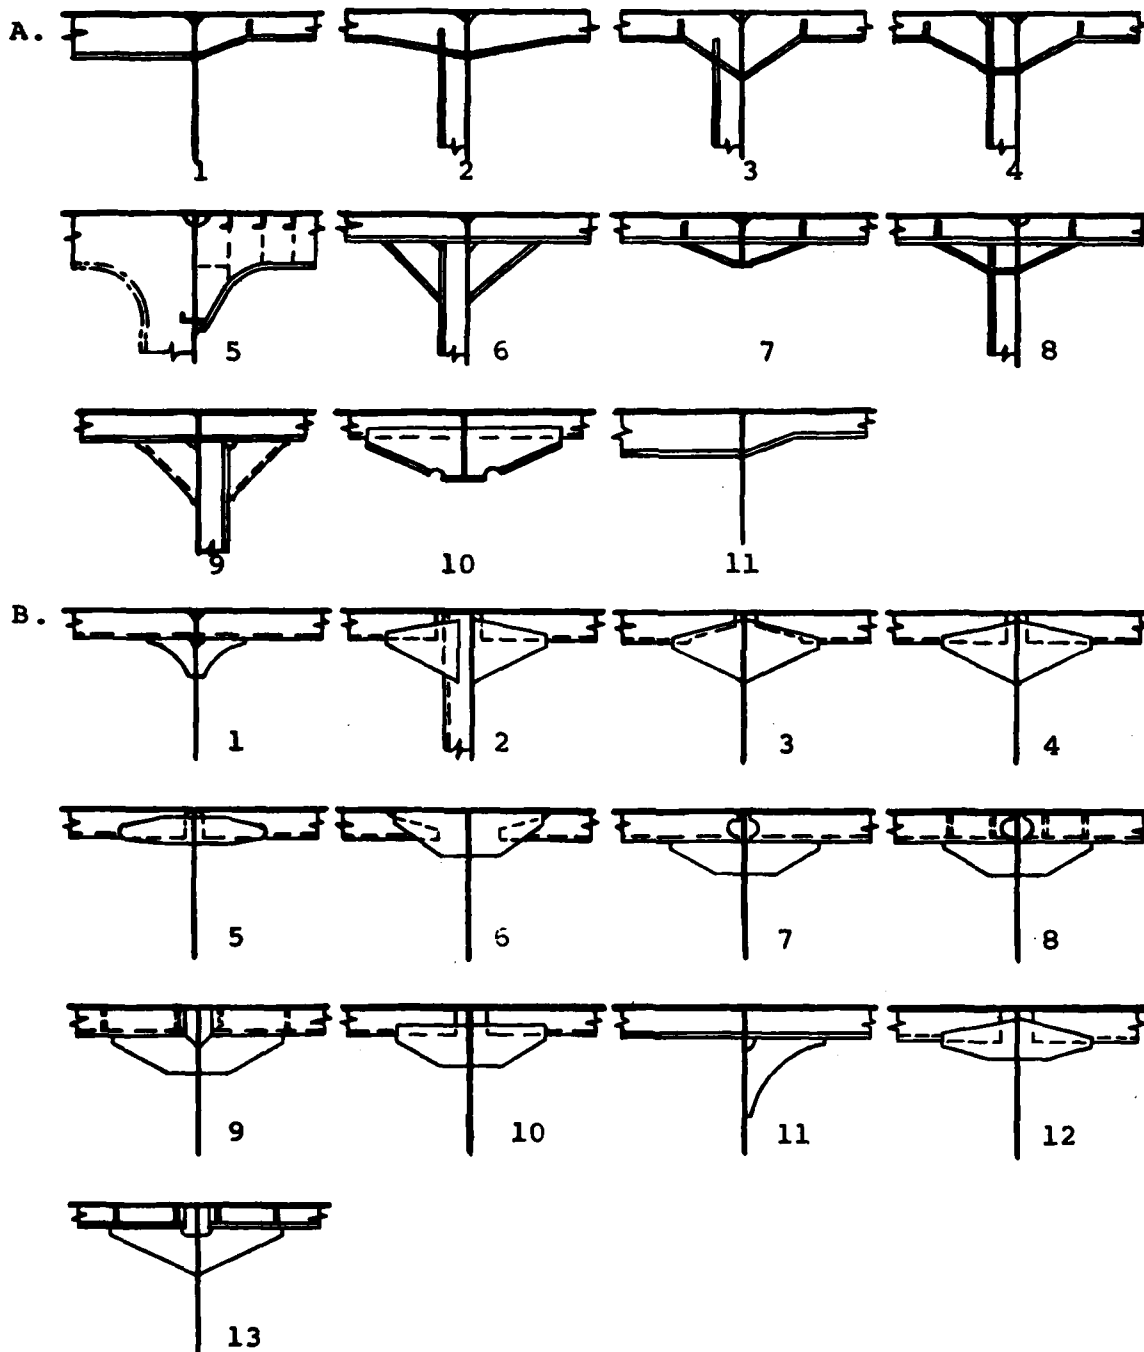
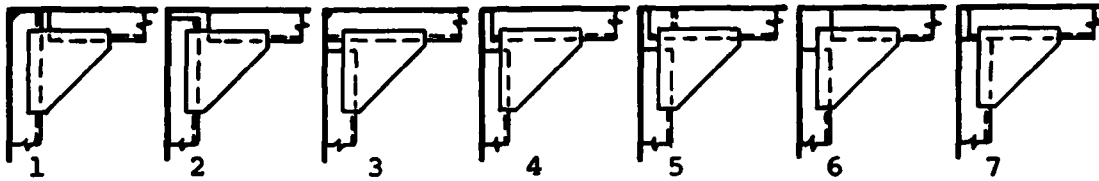
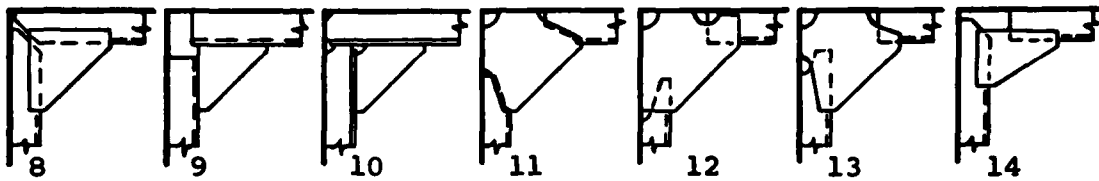
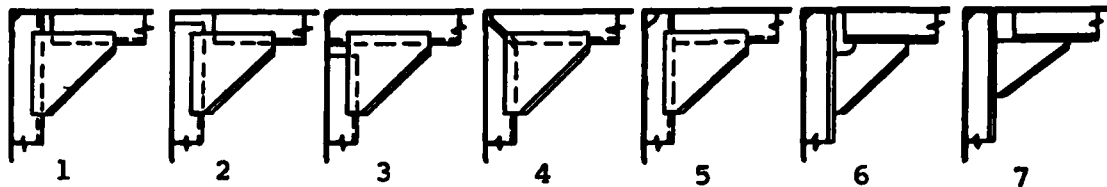
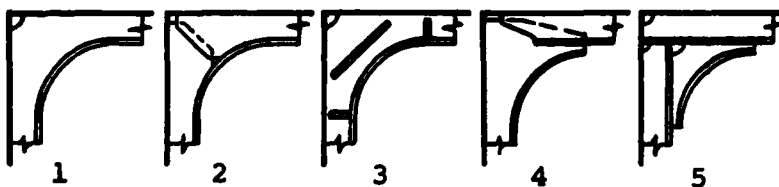
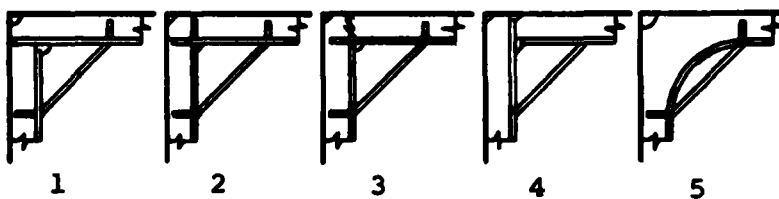
FIGURE 2

Figure 2 shows the 145 variations in configurations included in the 68,586 beam brackets observed in both surveys. The configurations that occur most often in the midship/cargo section of containerhips and general cargo ships are the corner bracket configurations 1-C-1, 1-C-25, 1-C-2, and 1-E-1. They also have a high failure rate, ranking number one, two, four and eight, respectively, in the top ten most prevalent failure details. In the first survey, detail 1-C-1 ranked third and detail 1-C-2 ranked eighth in the same category. Many of the group "C" corner bracket failures could be attributed to instability of the bracket plate panel. This was especially true on containerhips where long spans of shell framing were supported at the ends with unflanged triangular plate with very high breadth/thickness ratios. It was interesting to note that on general cargo ships where wood framing was attached to the shell framing flanges to protect the cargo there were less failures among the group "C" brackets. This was because the tightly wedged wood framing served as intermediate lateral supports for the shell framing and prevented the flanges from tripping under minor local collisions. The wood framing also assisted by forming a grid on the shell framing. Stability was not the problem with the group "E" flanged-plate brackets, because the shell framing or deck framing member usually cracked or buckled near the bracket connection first. Again, the major cause of these severe loads is collisions. It is realized that accidents do happen, but a lot of preventative measures, such as reinforced areas in the ship's hull designated as tug stations, and the use of heavy duty rubber fenders at piers and loading docks, could be applied.

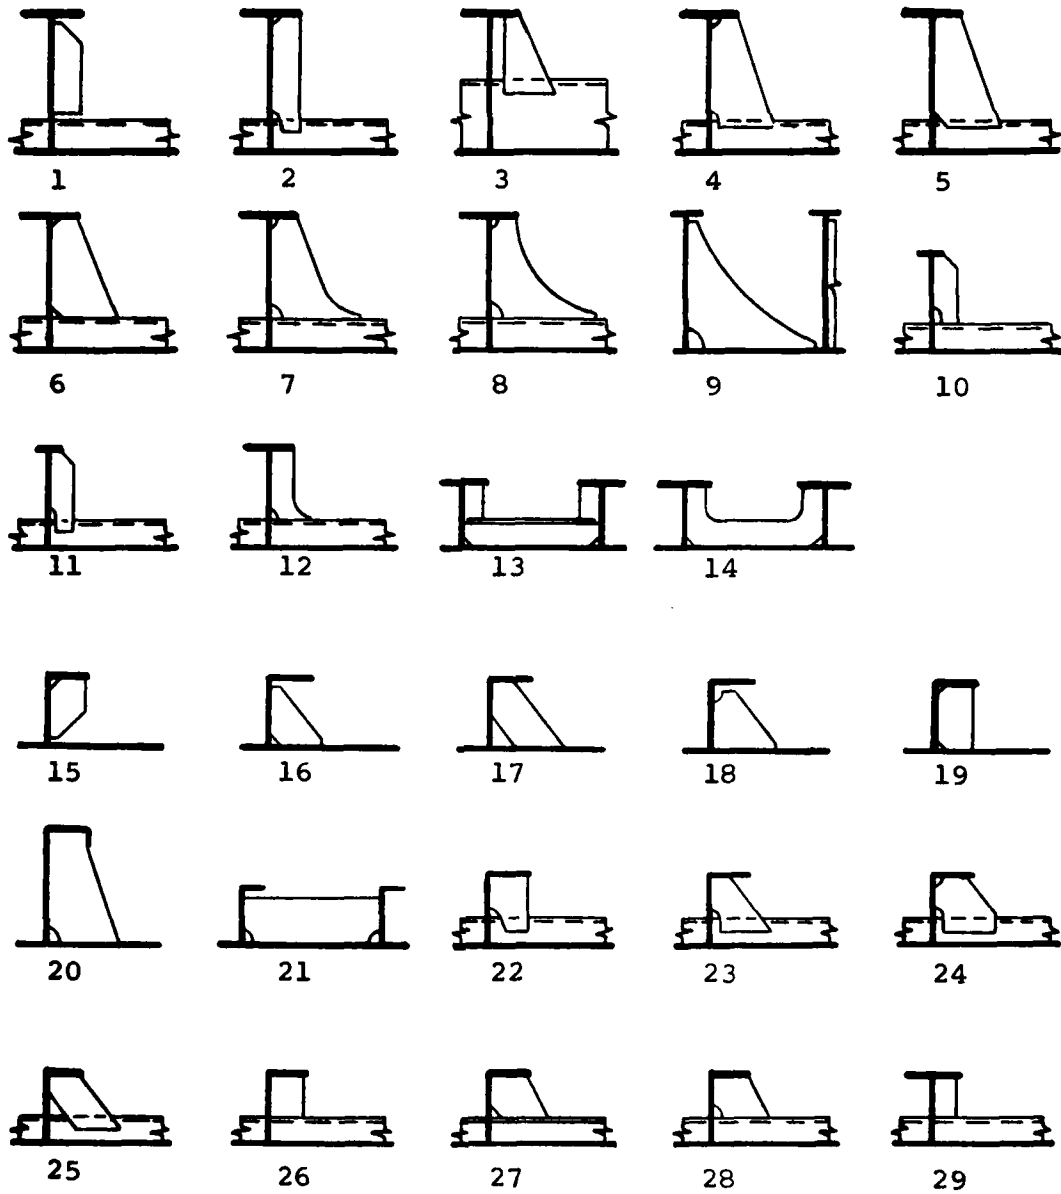
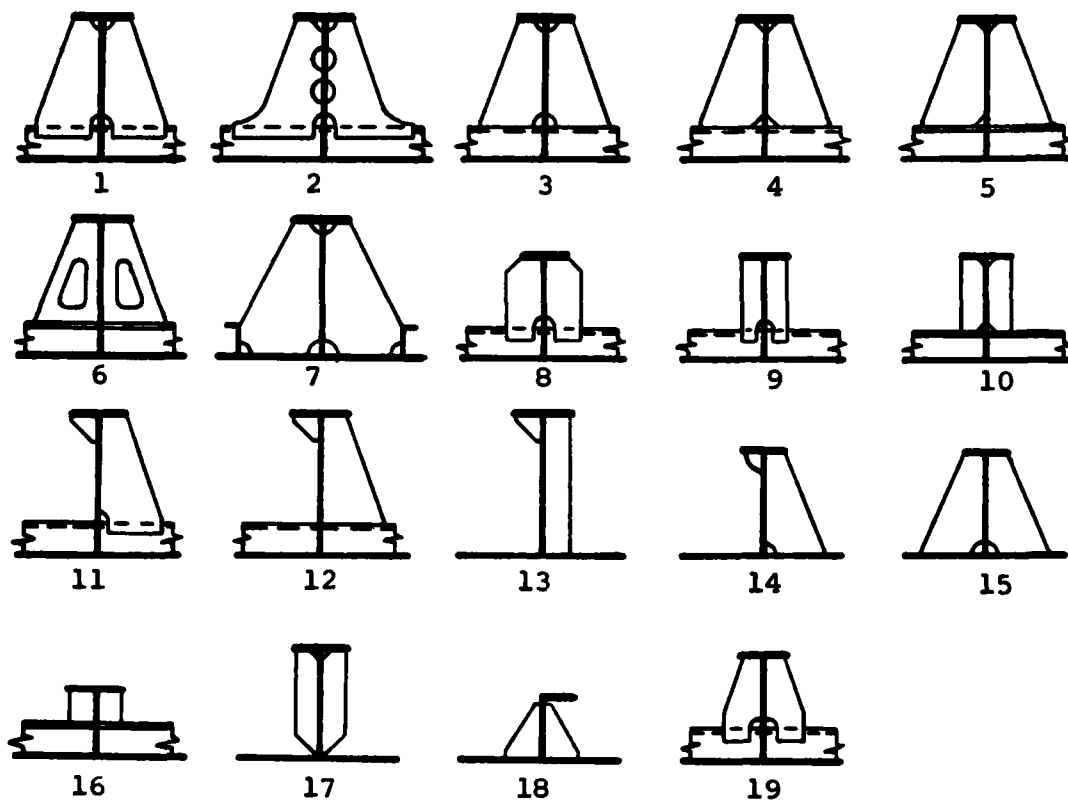
FIGURE 5

The three groups of tripping brackets, containing 82 different configurations, are shown in Figure 5. Sixteen new variations were found in the second survey with eleven belonging to group "C". Group "C" also continued to have the highest failure percentage rate of the three groups, thus, placing four details on the top ten most prevalent failure list and one detail on the top ten highest percentage failure list. Details 2-C-19, 2-C-11, 2-C-7, and 2-C-20 ranked third, fifth, sixth and tenth, respectively, under most prevalent failures. Details 2-A-20 and 2-C-27 were seventh and tenth under highest percentage failures.

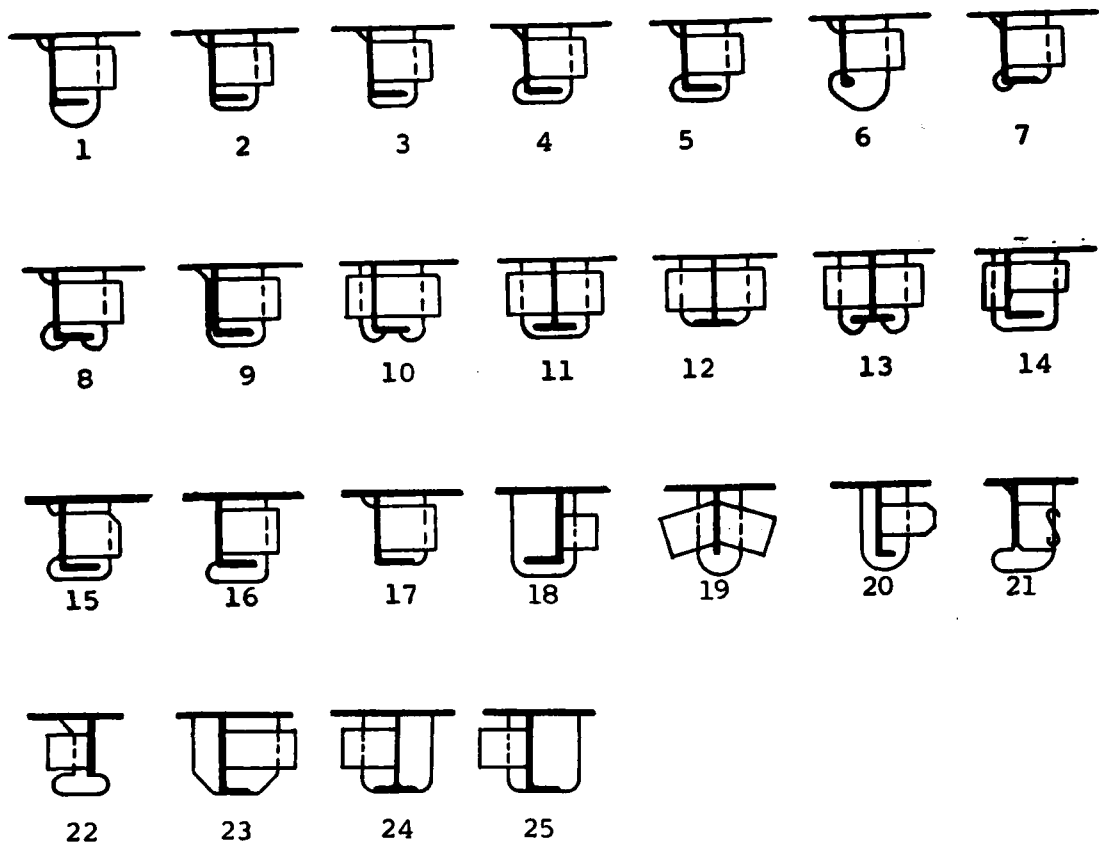
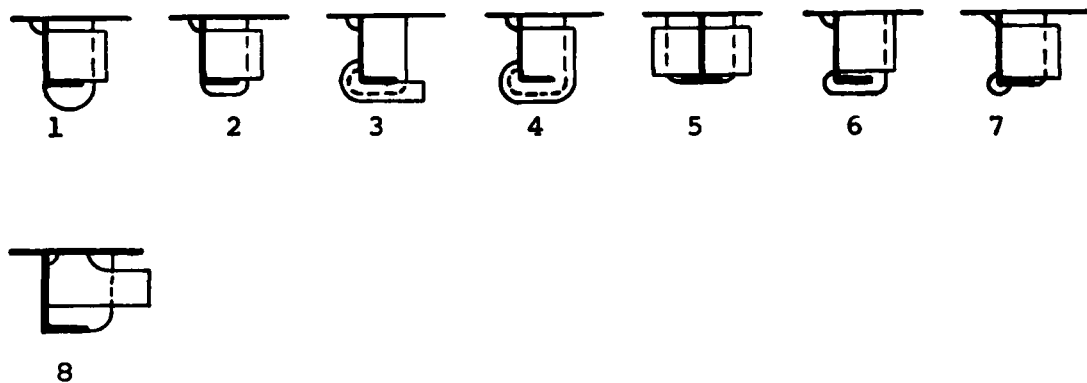
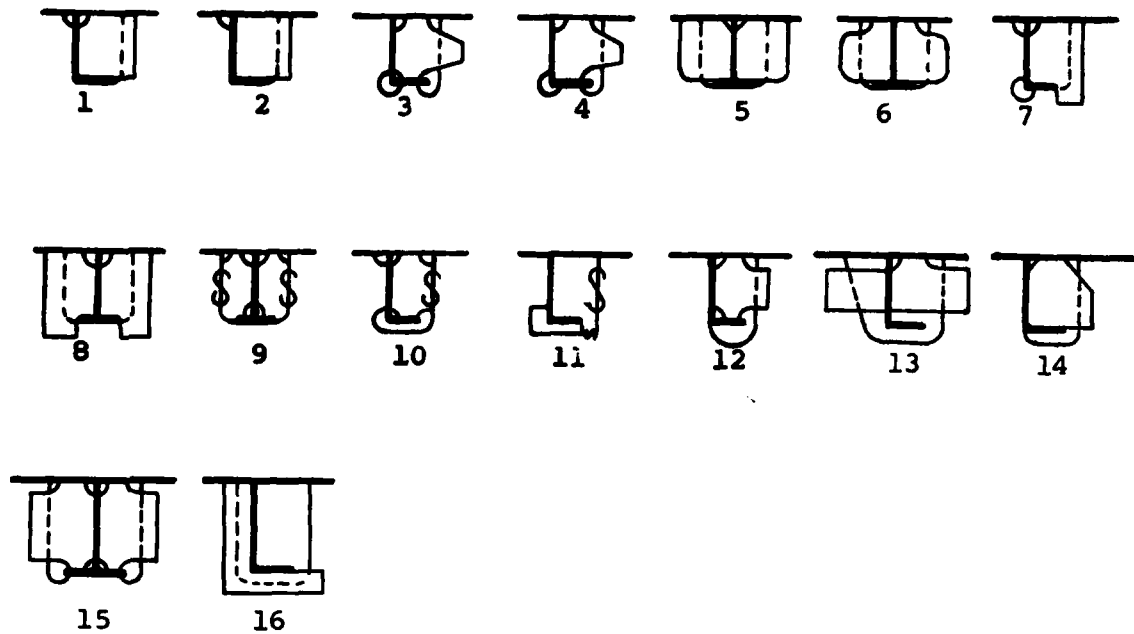
FIGURE 9  
NON-TIGHT COLLAR DETAILS  
FAMILY NO. 3

Of the 4,724 non-tight collar details observed in this thirty-six ship survey there were only five failures. Incomplete welding on detail 3-A-16 resulted in two detail failures on a bulk carrier while poor workmanship and bad welding accounted for three failures of detail 3-A-25 on a containership. Thirteen new variations in configurations were observed in this survey, thus resulting in an overall total of forty-nine configurations for the three group family. Figure 9 shows the forty-nine configurations, and Table 6 summarizes the results.

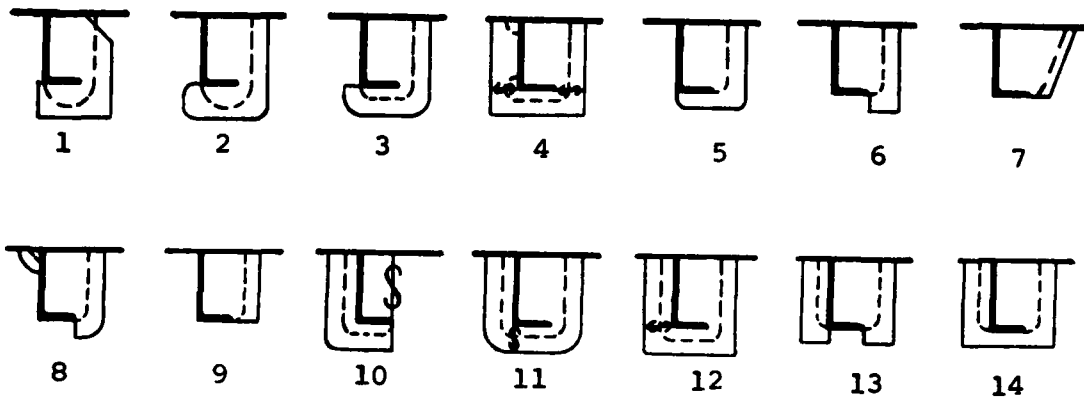
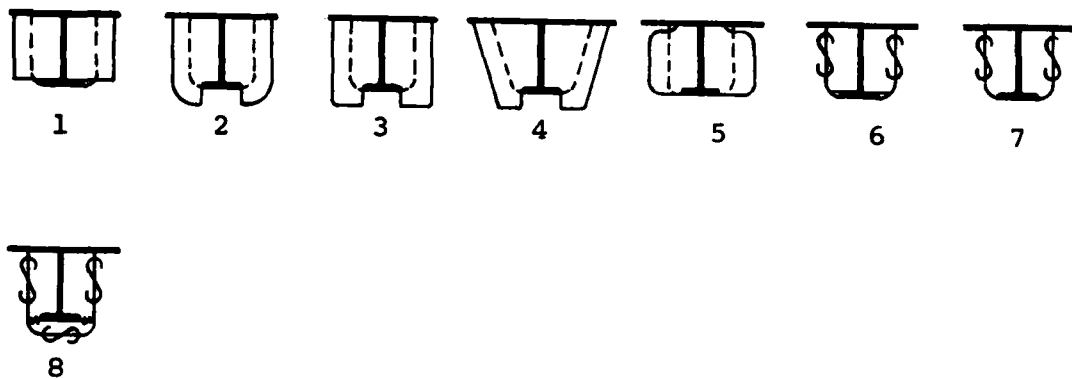
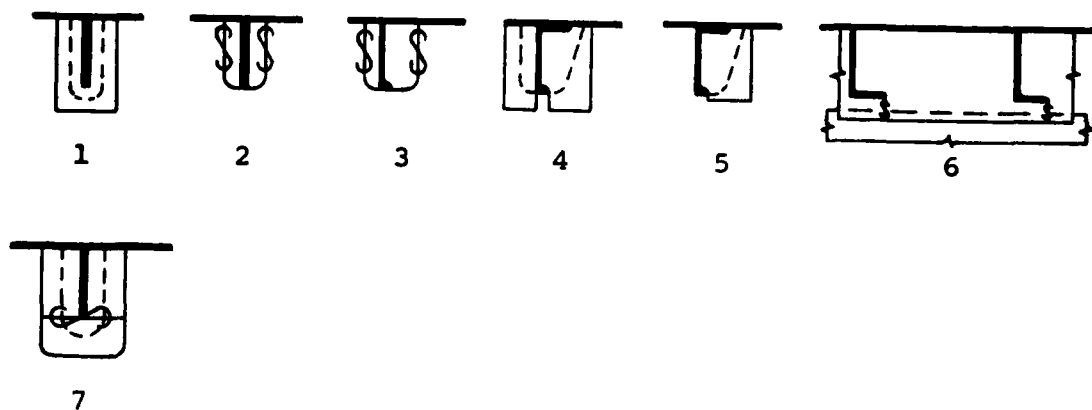
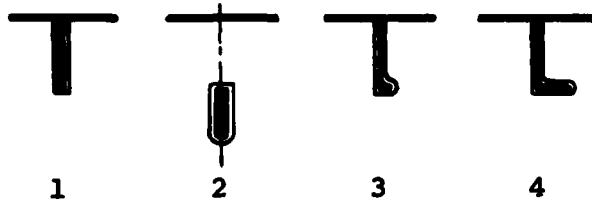
**FIGURE 10**  
**TIGHT COLLAR DETAILS**  
**FAMILY NO. 4**

Figure 10 contains the thirty-three variations in configurations observed for the family of tight collars. Detail 4-C-7 is the only new configuration identified in this survey. Table 7 is a summary of the number of sound details observed as well as the total observed for both surveys.

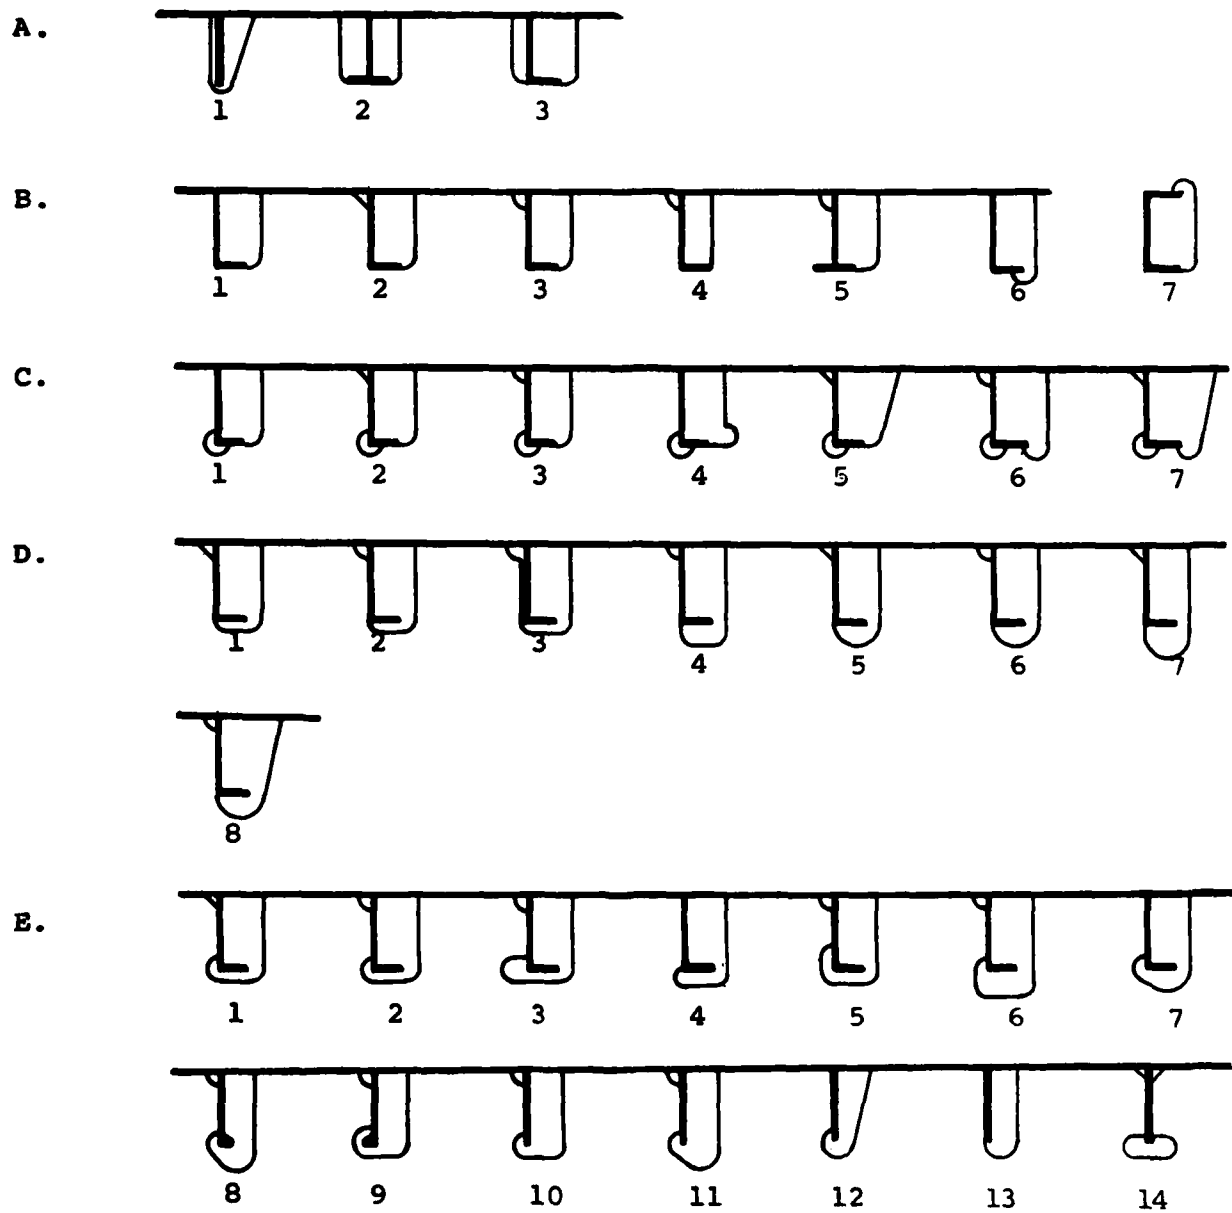
FIGURE 19  
CLEARANCE CUTOUTS DETAILS  
FAMILY NO. 8

The purpose of clearance cutouts is to maintain continuity of one member through another. There are thirty-nine variations in configuration for this family as shown in Figure 19. Details 8-A-3, 8-B-7, 8-E-13, and 8-E-14 are new configurations identified in this survey. The details are grouped according to geometrical shape or attachment to the impeding structural member. Results for this grouping are summarized in Table 10.

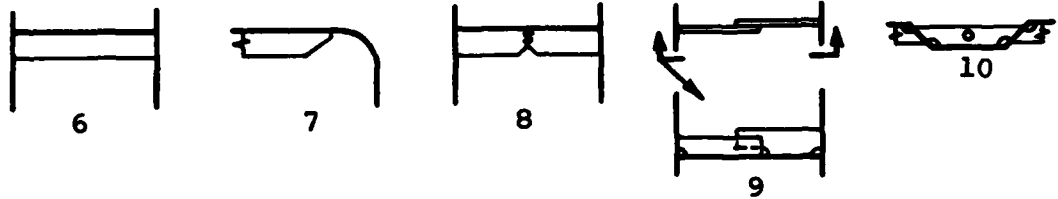
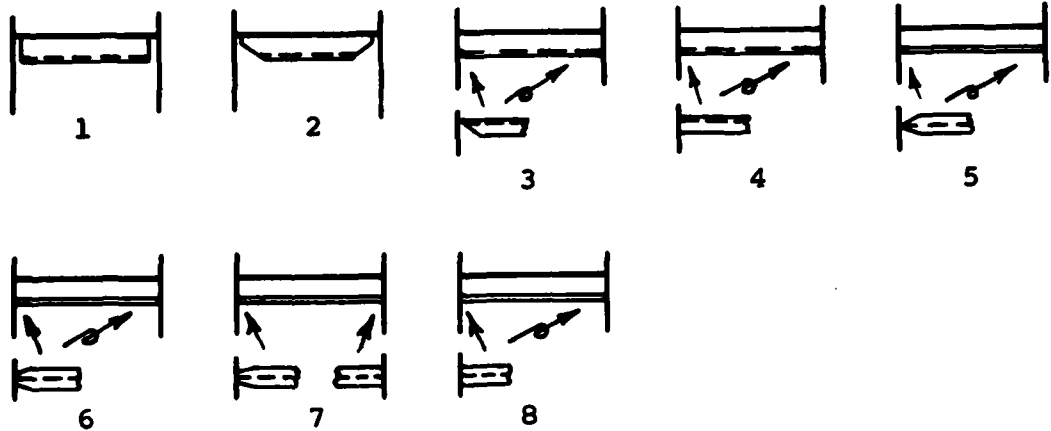
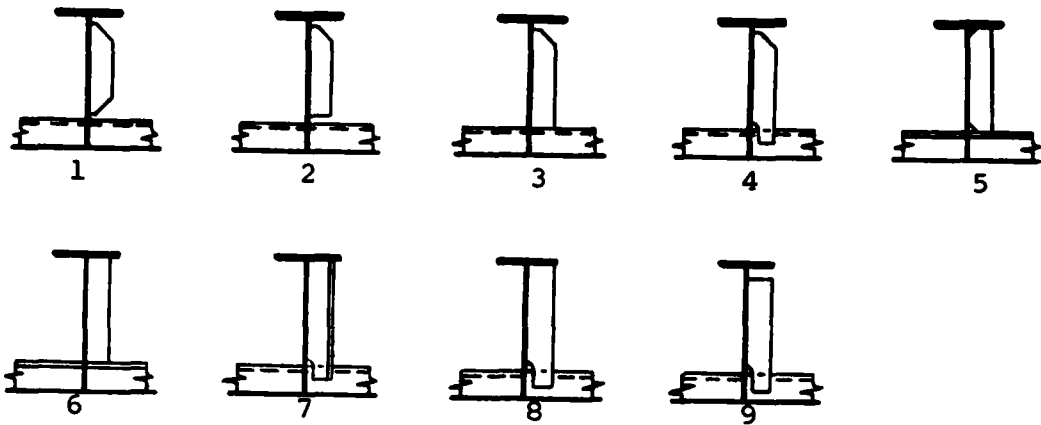
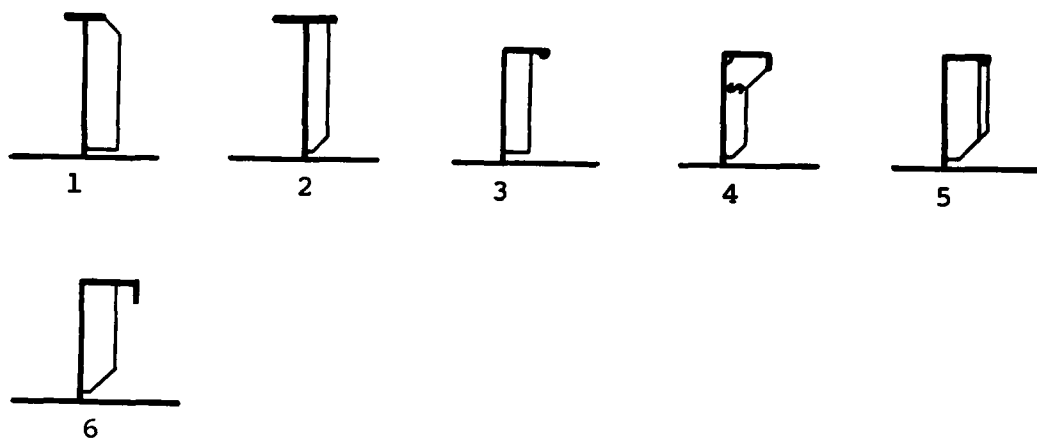
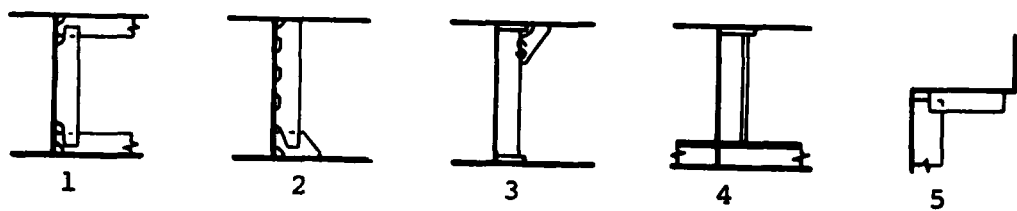
FIGURE 28

In this family, panel stiffeners are defined as structural angles, tees, or flat bars welded to large panels of plate for the purpose of preventing local instability of the plate. They are not designed as direct load-carrying members. There was only one new configuration found in survey number two, which brings the total to forty-one as shown in Figure 28. Table 14 is a numerical summary, by family group, of the configurations shown in Figure 28.

The panel stiffeners had 527 failures which is a failure rate of 3.82% in the second survey. This failure rate is very high compared to the 0.65% failure rate recorded in the first survey. One possible explanation could be attributed to the more than two hundred panel stiffener failures by corrosion found on one general cargo ship. The captain explained that for five years during the Vietnam War, the ship carried nothing but ammunition and explosives. During that time, no maintenance, including painting, was performed by the crew due to the volatile

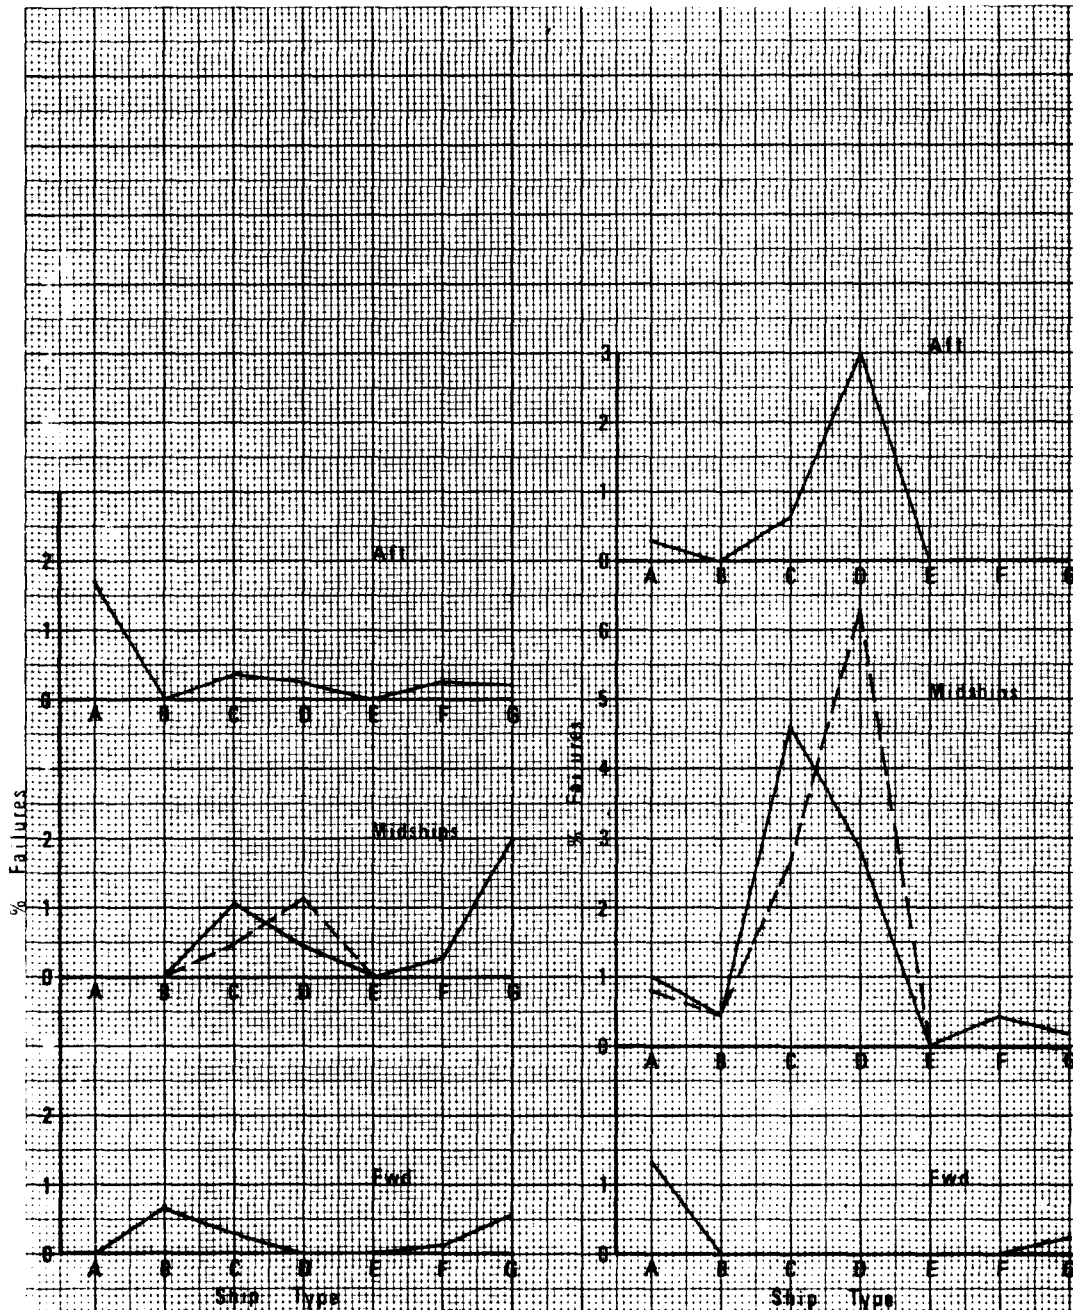
FIGURE 40

FAMILY NO. 11  
STIFFENER ENDS
